RI 9253

REPORT OF INVESTIGATIONS/1989

Relationships Between Annulus Thickness and the Integrity of Resin-Grouted Roof Bolts

Report of Investigations 9253

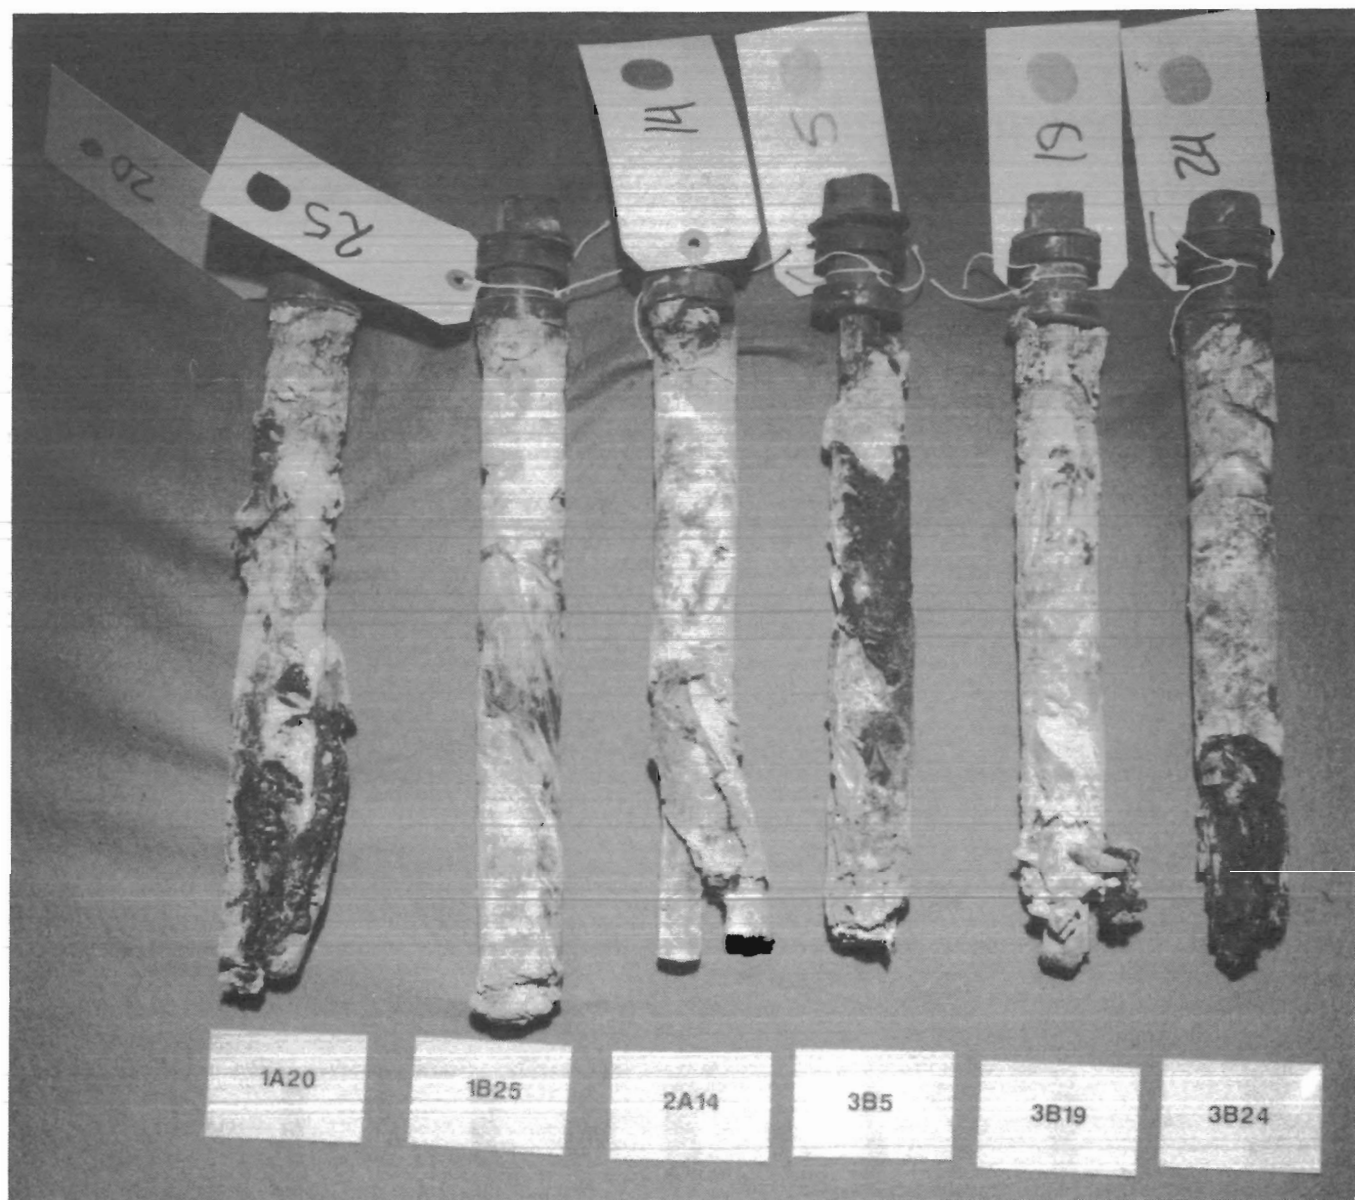
The grout from test bolts in the 1-1/4- and 1-1/2-in-diam drill holes was soft, black, and sticky. The remaining grout-column length was longer than that on bolts with 1-in-diam drill holes. Large pieces of plastic wrapper were present, especially in the grout from the set of bolts with 1-1/2-in-diam holes (figs. 7-8). The grout in the bottom 1 in of all tested drill-hole diameters was not mixed at all.

Figure 8.-Bolts from 1-1/2-in-diam holes, test 2.
